HAZARDOUS MATERIALS ACCIDENT
IN THE RAILROAD YARD OF THE
NORFOLK AND WESTERN RAILWAY AT
DECATUR, ILLINOIS
JULY 19, 1974

NATIONAL TRANSPORTATION SAFETY BOARD
Washington, D.C. 20594
REPORT NUMBER: NTSB-RAR-75-4

ADOPTED: APRIL 10, 1975

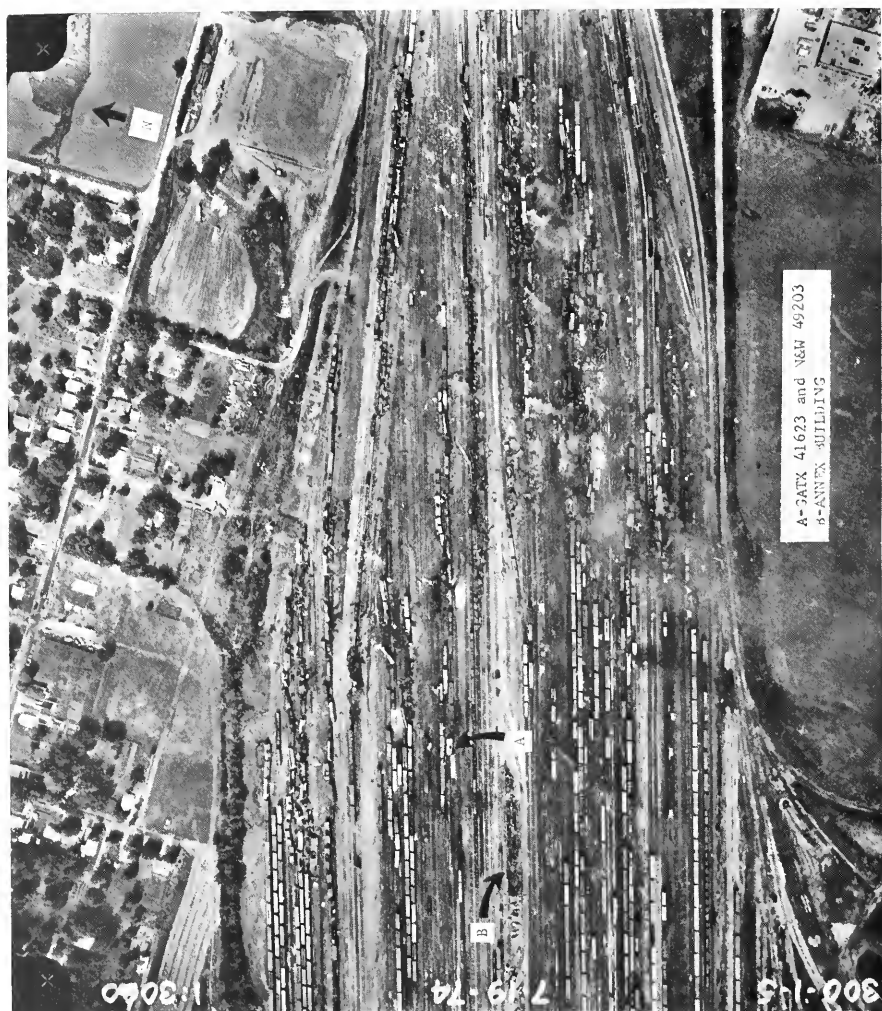
Liquid isobutane spilled from the 22-inch by 26-inch puncture at the rate of about 5,000 gallons per minute. The liquid vaporized, and a northwest wind spread the cloud southeastward for about 8 to 10 minutes. The cloud was then ignited by an unknown source and exploded violently. (See Figure 2.)

Figure 2. The explosion area in Decatur Yard.

At Decatur the open-air explosion of the gas-air mixture is substantiated by two significant facts: (1) All cars containing commodities which could explode were accounted for after the explosion; (2) there were no craters after the explosion. Such an explosion would have required a carload of explosive material and would have caused a large crater.

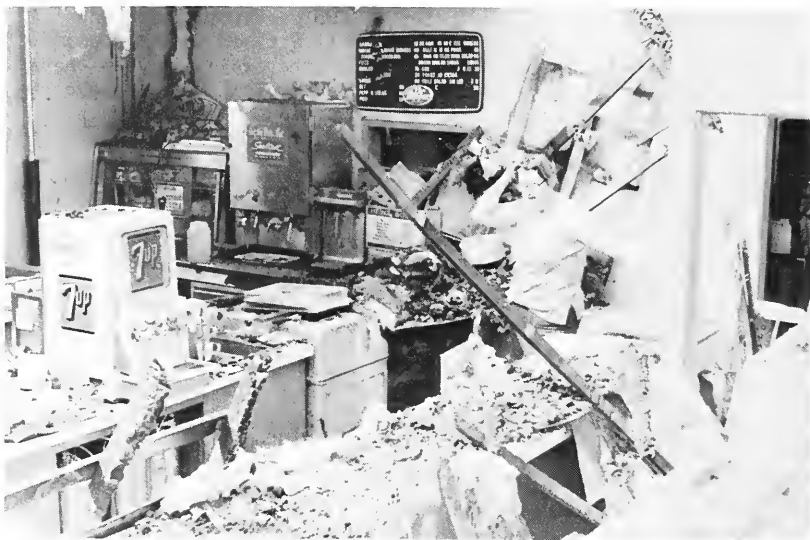
About 700 residences were damaged by concussion, 67 of which authorities declared uninhabitable; damage ranged from broken windows to collapsed roofs and walls. Many furnishings were damaged by flying glass and other debris. Lakeview High School, which was adjacent to the east-bound yard, was one of the most severely damaged buildings. An unfinished addition to the school was demolished. Ten other schools were also damaged. (See Figures 3 and 4.) Thirty-one commercial establishments reported damages to structures and contents.

Figure 3. Typical Damage, Residential Area
Decatur, Illinois

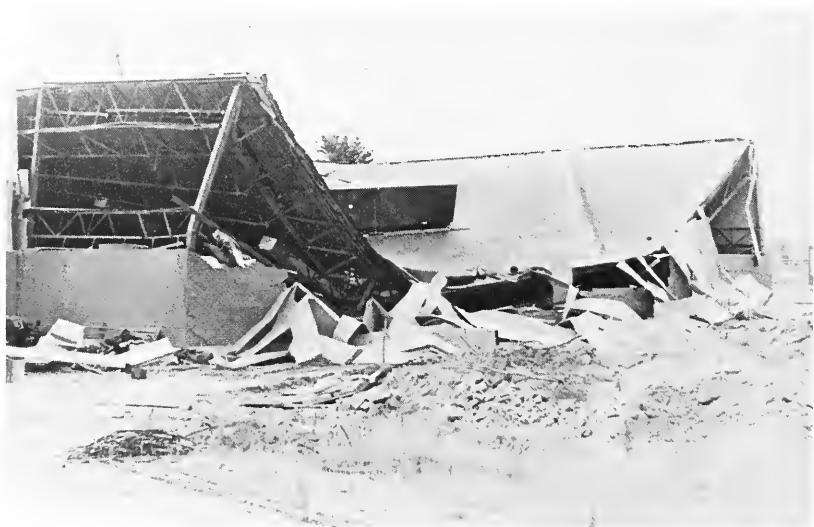
Figure 4. Damage to Lake View School, Decatur, Illinois.

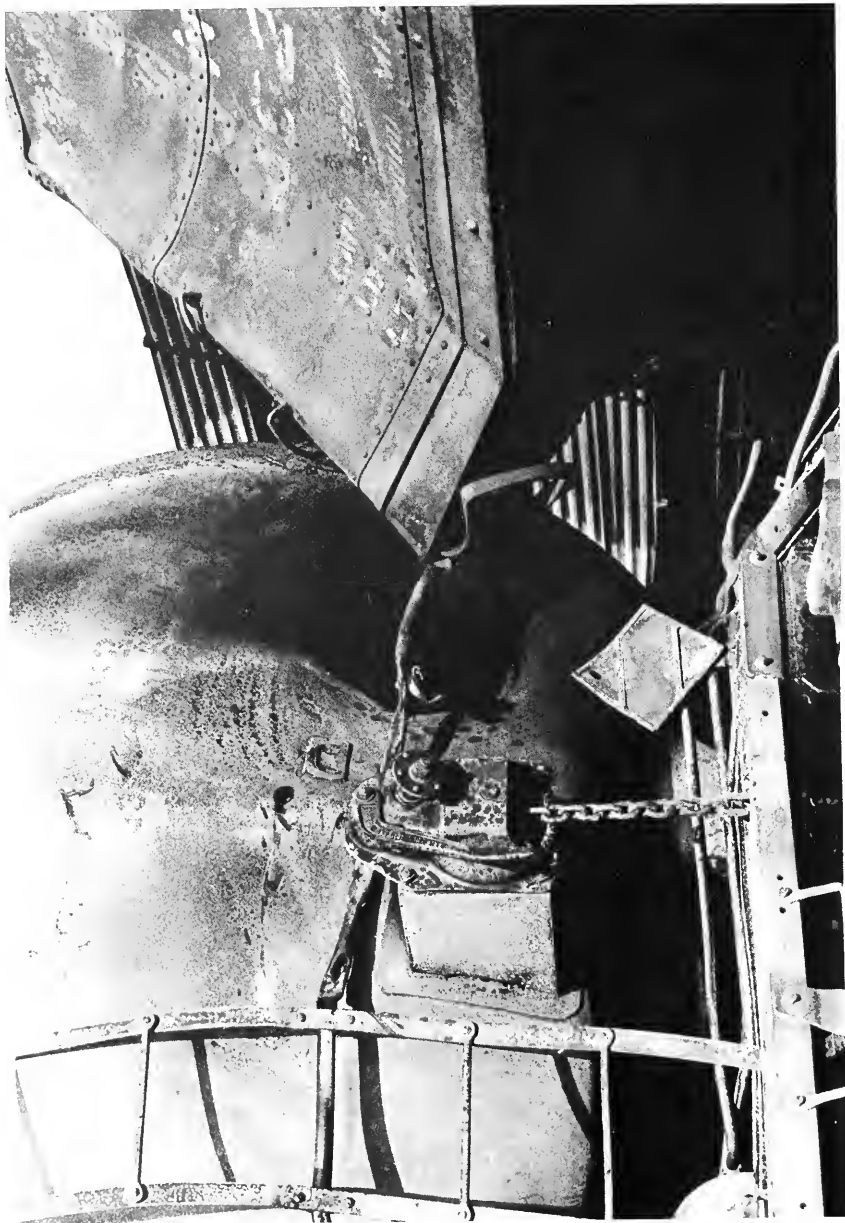
In addition to the 22-inch by 26-inch puncture, the running board, handrail, airbrake equipment, handbrake mechanism, and coupler on the east end of the car were damaged. The east end of the car was also burned. (See Figure 5.)

Figure 5. "B" end of GATX 41623.

The marks on the coupler of the punctured tank car and on the coupler of the empty boxcar clearly indicate that the two couplers engaged at first impact. To puncture the tank, the boxcar coupler had to disengage vertically, override the coupler of the tank car, and strike the head of the tank with sufficient force. The broken carrier iron on the boxcar indicates that an initial downward movement of that coupler, then a rebound upward, caused the vertical separation. That action is consistent with what one would expect when an unusually heavy cut of large tank cars moving at excessive speed attempts to couple to a free-standing light boxcar.

- (1) Promulgate regulations to limit losses in accidents involving the transportation of bulk hazardous materials by rail. (Recommendation No. R-75-18)
- (2) Determine the capabilities of top and bottom shelf couplers, head shields, and a combination of both, and issue regulations to require that DOT-112A and -114A tank cars be equipped with the best practical combination. (Recommendation No. R-75-19)
